**Flood Control Project Maintenance
Levee Inspections**
LMA District Cover Sheet
Spring 2010 Levee Inspection Results

Reclamation District No. 2094 Wathal

Levee Inspection Report By Mile - Spring 2010

Waterway						Bank	Unit Miles	Inspection Start/End	Inspector	
Unit No. 01 San Joaquin River						Right	2.82	04/06/2010 04/06/2010	John Paasch	
LMR No	Levee Mile		Category	Item	Location *	Rating **	Action/Comment	GPS Latitude/Longitude		Issue No. Photo
	Start	End						Start	End	
1	0.49	0.49	Earthen Levee	Animal Control	WS	M	No rodents visible, but rodent burrows visible; need to backfill and compact or grout borrows. Inspector Comments: Burrow holes on slope and toe. Seven holes in 5' radius.	37.768593 ° -121.297560 °	37.768593 ° -121.297560 °	5 Y
2	0.66	0.66	Earthen Levee	Encroachments	WS	W	Pipe Inspector Comments: 14" steel irrigation intake with sluice gate.	37.767505 ° -121.294902 °	37.767505 ° -121.294902 °	1 Y
3	1.12	1.12	Earthen Levee	Erosion / Bank Caving	WS	C	Schedule repair of erosion site prior to the next inspection.	37.761845 ° -121.295311 °	37.761845 ° -121.295311 °	9
4	1.26	1.26	Earthen Levee	Encroachments	WS	W	Pipe Inspector Comments: 20" irrigation intake, sluice ga

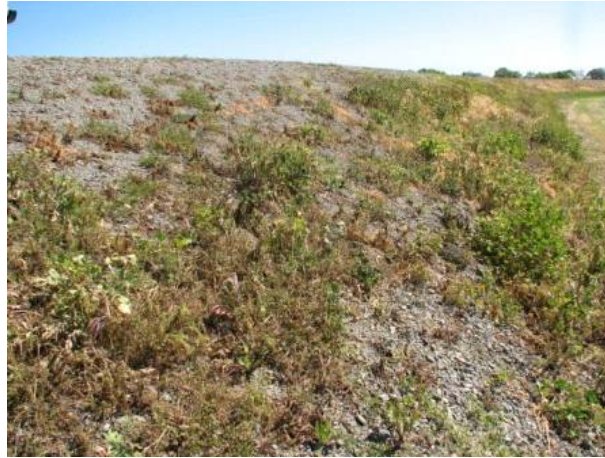
jpaasch_s_20100406_257.jpg

Levee Mile Report Line	1
Start Levee Mile	0.49
End Levee Mile	0.49
Location	Water Side
Category	Earthen Levee
Item	Animal Control

Numerous animal burrows located on waterside slope.

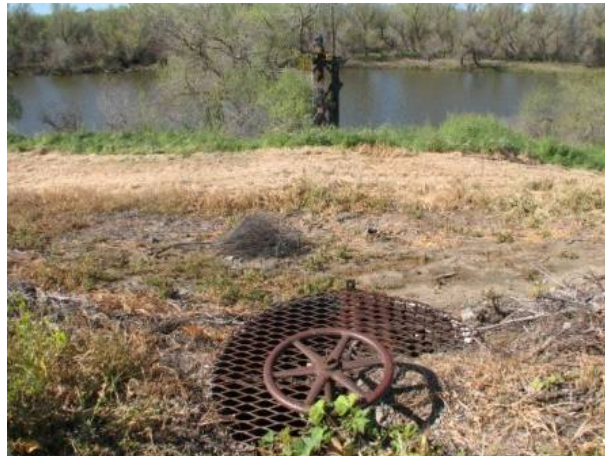
jpaasch_s_20100406_259.jpg

Levee Mile Report Line	2
Start Levee Mile	0.66
End Levee Mile	0.66
Location	Water Side
Category	Earthen Levee
Item	Encroachments

Irrigation intake on San Joaquin River. Positive closure device (sliuce gate) on water side hinge points. Pipe is through freeboard portion of levee. Concrete stand pipe beyond landside toe.

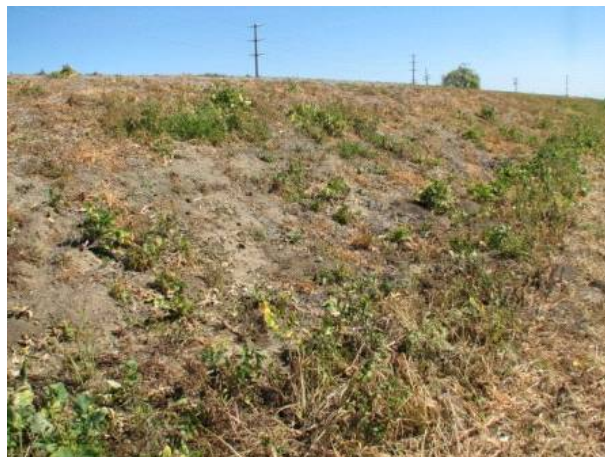
jpaasch_s_20100406_258.jpg

Levee Mile Report Line	6
Start Levee Mile	2.14
End Levee Mile	2.14
Location	Water Side
Category	Earthen Levee
Item	Animal Control

Animal burrows on waterside slope.

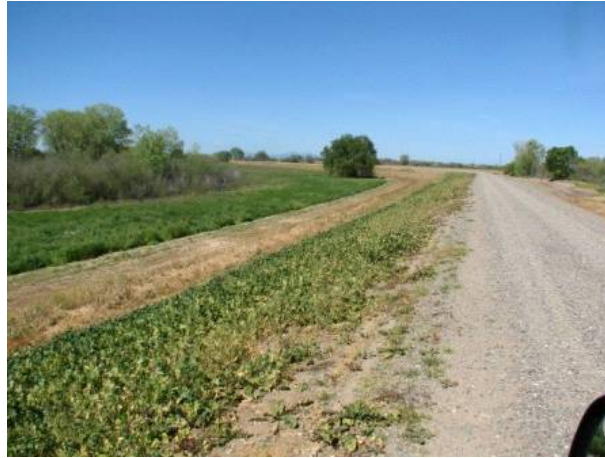
jpaasch_s_20100406_256.jpg

Levee Mile Report Line	1
Start Levee Mile	0.01
End Levee Mile	0.46
Location	Water Side
Category	Earthen Levee
Item	Vegetation

Annual grasses and weeds on waterside slope.

LMR No	Levee Mile		Category	Item	Location *	Rating **	Action/Comment	GPS Latitude/Longitude		Issue No.
	Start	End						Start	End	Photo
1	0.01	0.46	Earthen Levee	Vegetation	WS	A	Control annual grass and weeds on the levee slopes and easements.	37.759267 ° -121.299585 °	37.760582 ° -121.307288 °	3 Y
